# Decontamination and Decommissioning of the Organic Moderated Reactor Experiment Facility (OMRE)

Robert E. Hine

September 1980

**EG&G Idaho, Inc.  
Idaho Falls, Idaho 83415**

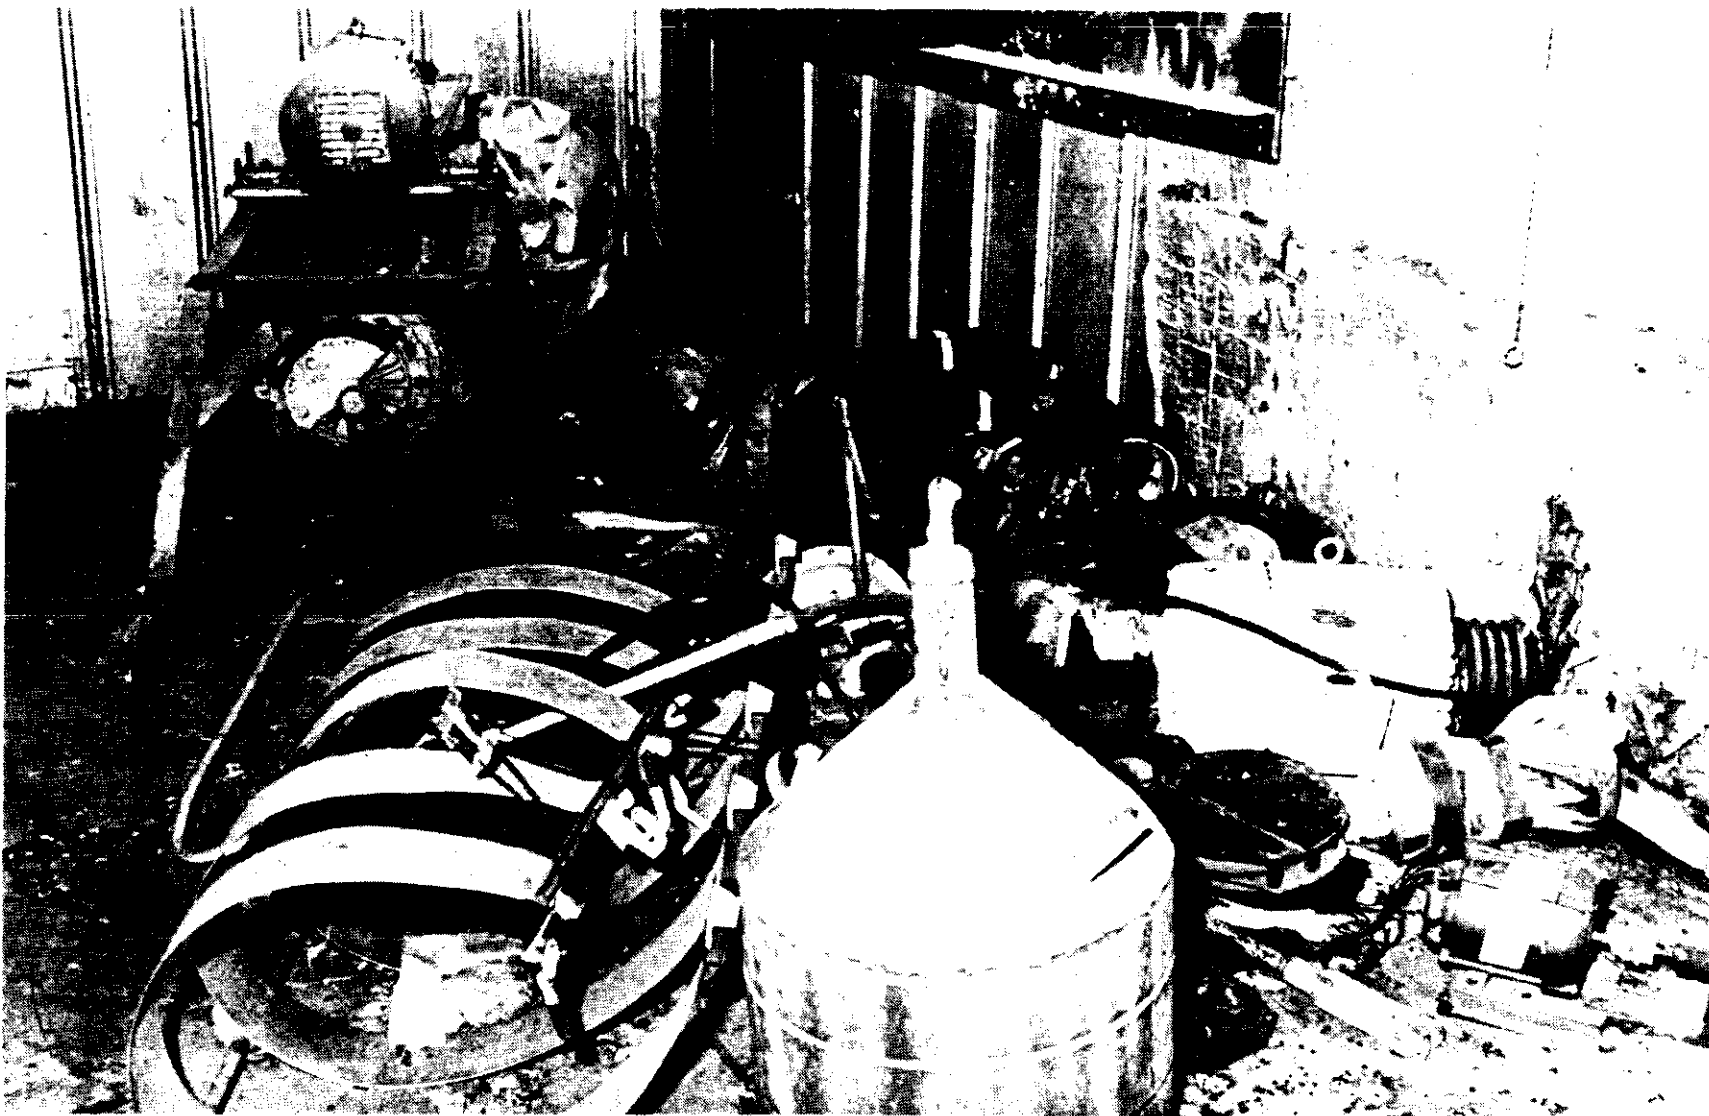
**Cleanup.** The first work phase was a general cleanup of the facility. Figures 14 and 15 show the general disarray found at the OMRE site. The loose items found were surveyed and disposed of appropriately.

Figure 14. Miscellaneous equipment in the process equipment building.

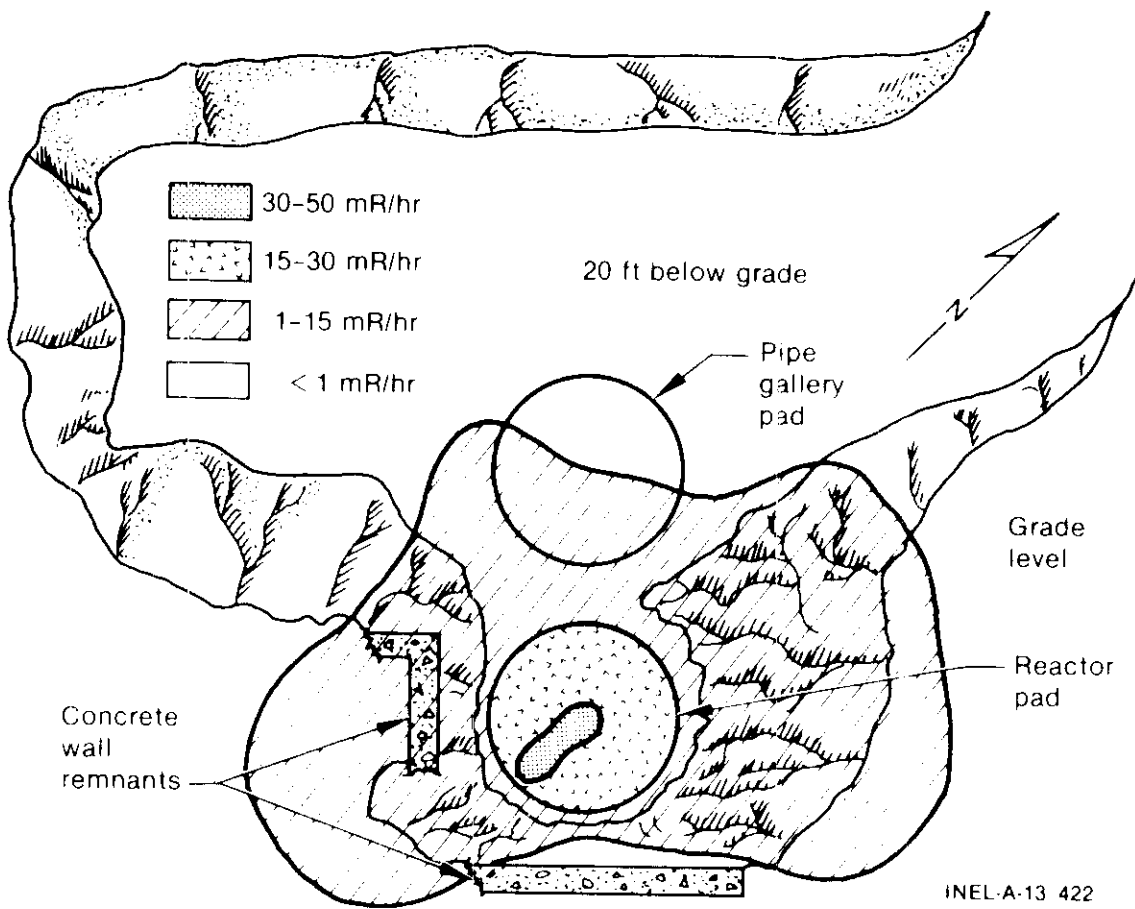
Figure 63. Radiation map of OMRE excavation.

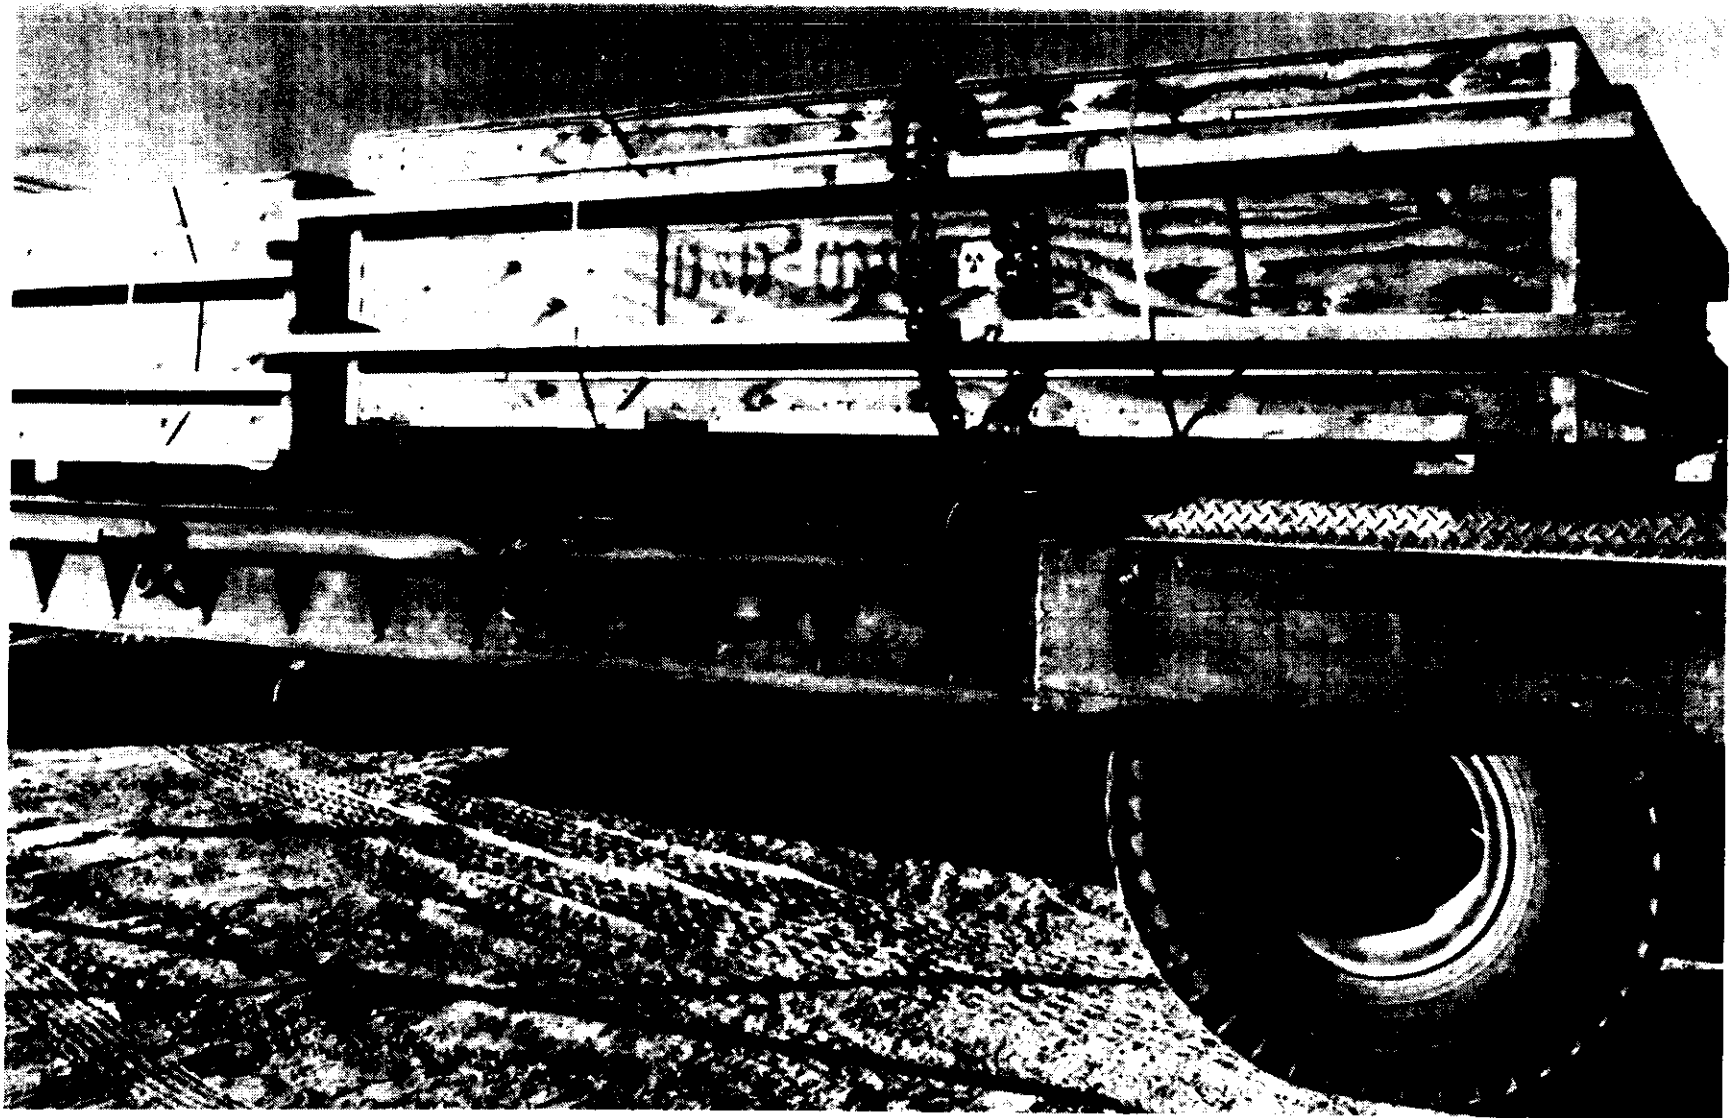
In October 1978, a shipment of radioactive soil enroute from OMRE to RWMC sprung a leak and spilled an estimated 0.5 ft<sup>3</sup> of soil. An investigation of this incident was conducted by a specially appointed committee, and a report<sup>16</sup> was issued with recommendations aimed at preventing future such incidents. In summary, one 2 x 4 x 8 ft plywood box (about 5,500 lbs) was transported with supports under the ends only and the weight of the soil opened a bottom seam of the box. Figure 72 shows the improperly loaded box with the unsupported center and a tie-down chain aggravating the situation. Figure 73 shows one box on the verge of opening the bottom seam, and Figure 74 is a close-up view of the opened seam. Some soil was collected from the truck bed, and radiation was measured at 5,000 cpm. The personnel involved, the truck tires, and roadway were monitored and no detectable radiation was found. As a result of this incident the box design was strengthened and specific instructions regarding shipping and tie-down were emphasized.

Figure 72. Improper loading of soil box.

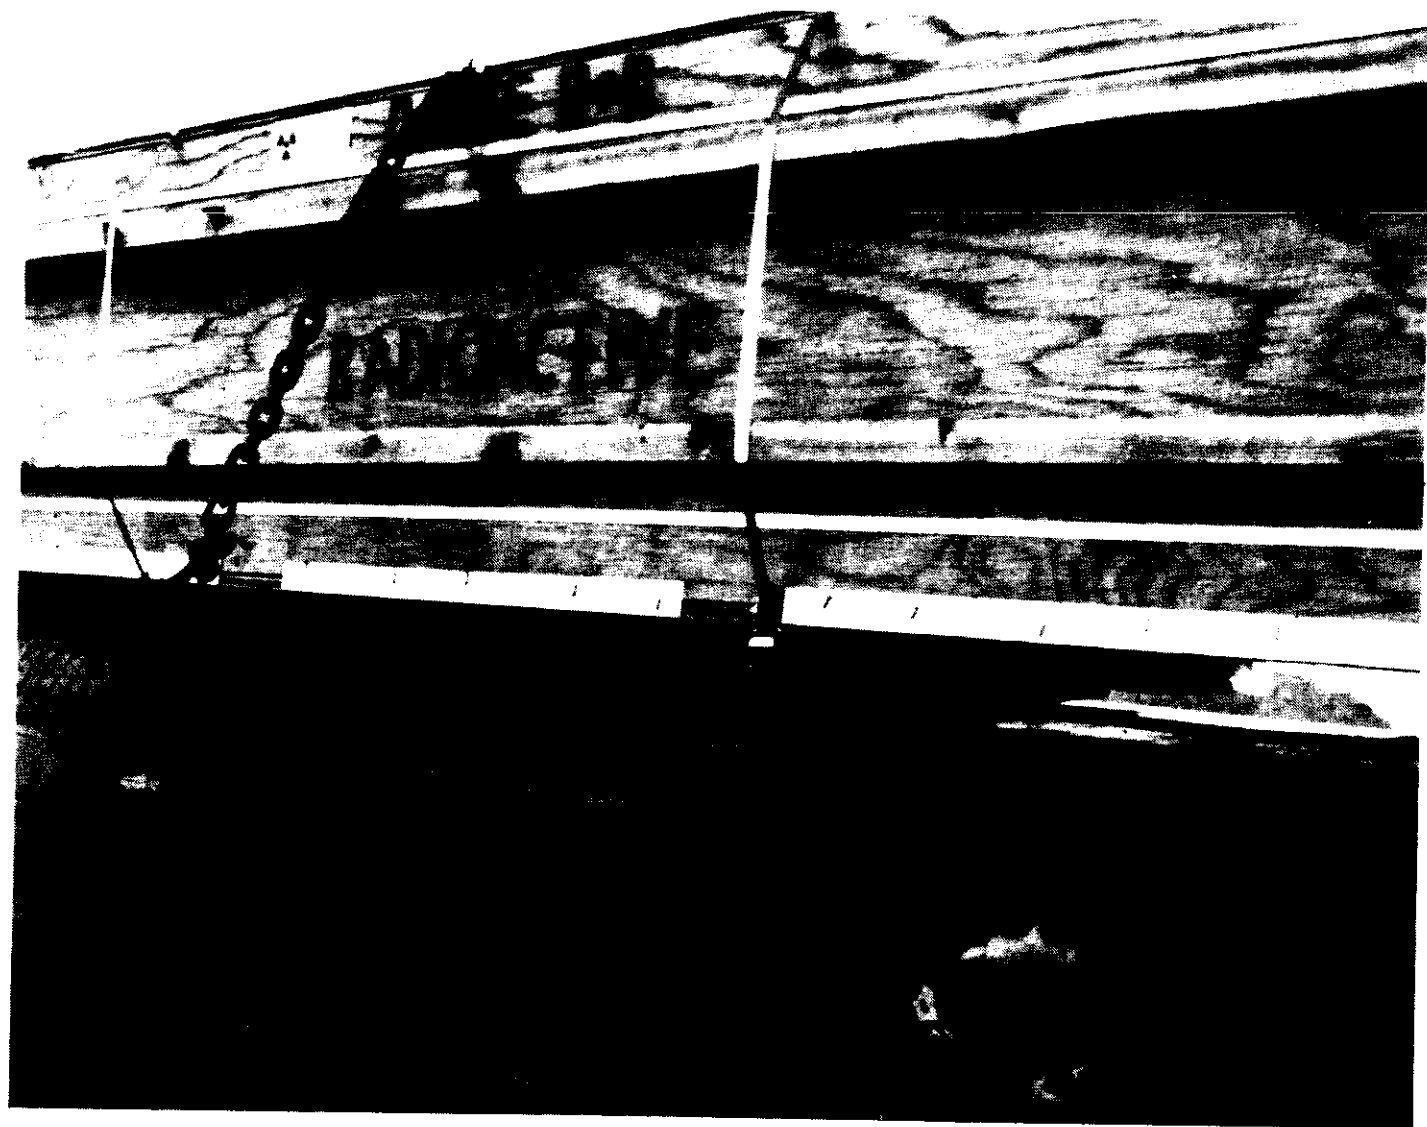
Figure 73. Soil box skids separating because support was inadequate.
